TURBINE ENGINE FUEL CONTROL RELIABILITY
TEST AND EVALUATION

Colt Industries, Incorporated

Army Air Mobility Research and Development
Laboratory

July 1974

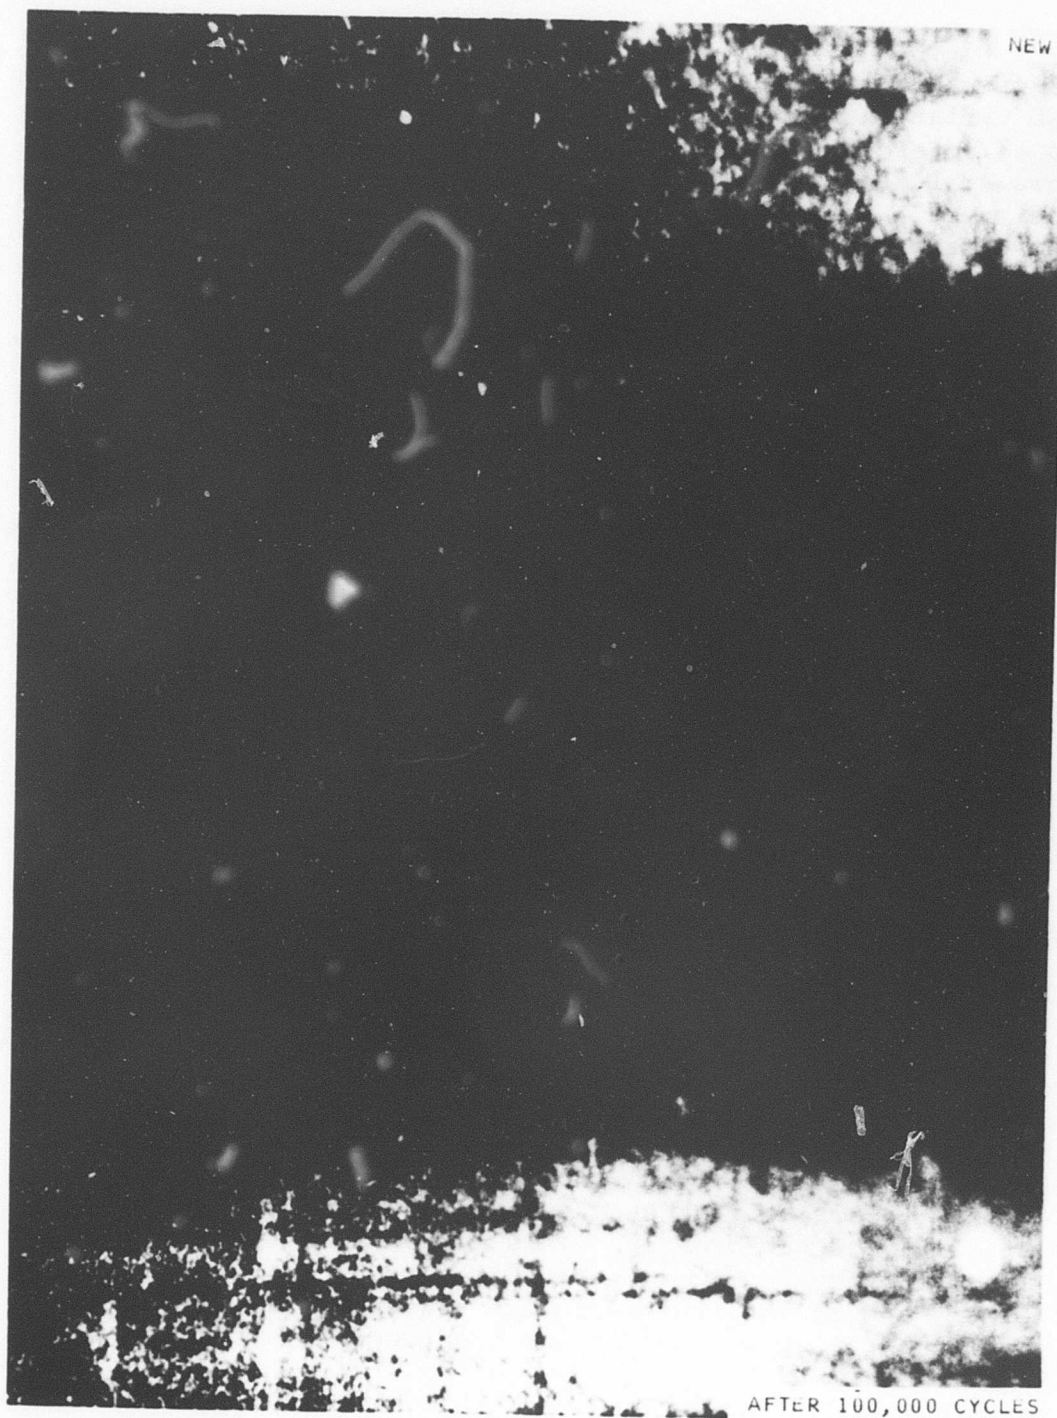
Figure 36. Translational Seal Nitrile C-69.

The last seal listed in Table 11 was a nitrile compound C-69. This is the same type of seal as the rotary listed in Table 10, although a different size was used. In each case, all six samples completed 100,000 cycles without leakage. This seal was reviewed as a rotary seal. The analysis of the rotary type applies as well to the translational type. Comparing the changes in physical properties listed in Tables 10 and 11, it is obvious that these changes were consistent, indicating again a stable material. More significant is the fact that the majority of the samples tested experienced changes contained within a very narrow band, further confirming the consistent quality from one seal to another. Figure 36 shows two seals side-by-side; one new, the other after 100,000 cycles. Axial wear lines are visible on the tested seal. These wear lines are less than 0.0005 inch wide and do not appear to be very deep. The mold flashes are visible in both seals, indicating little wear in the tested seal. There is no evidence of flatness or deformation.
